ANNUAL REPORT FOR 2010

**UT to Bald Creek (Hydro Site) Permit Site #7
Mitigation Site
Yancey County
TIP No. R-2518B**

Prepared By:
Natural Environment Unit & Roadside Environmental Unit
North Carolina Department of Transportation
December 2010

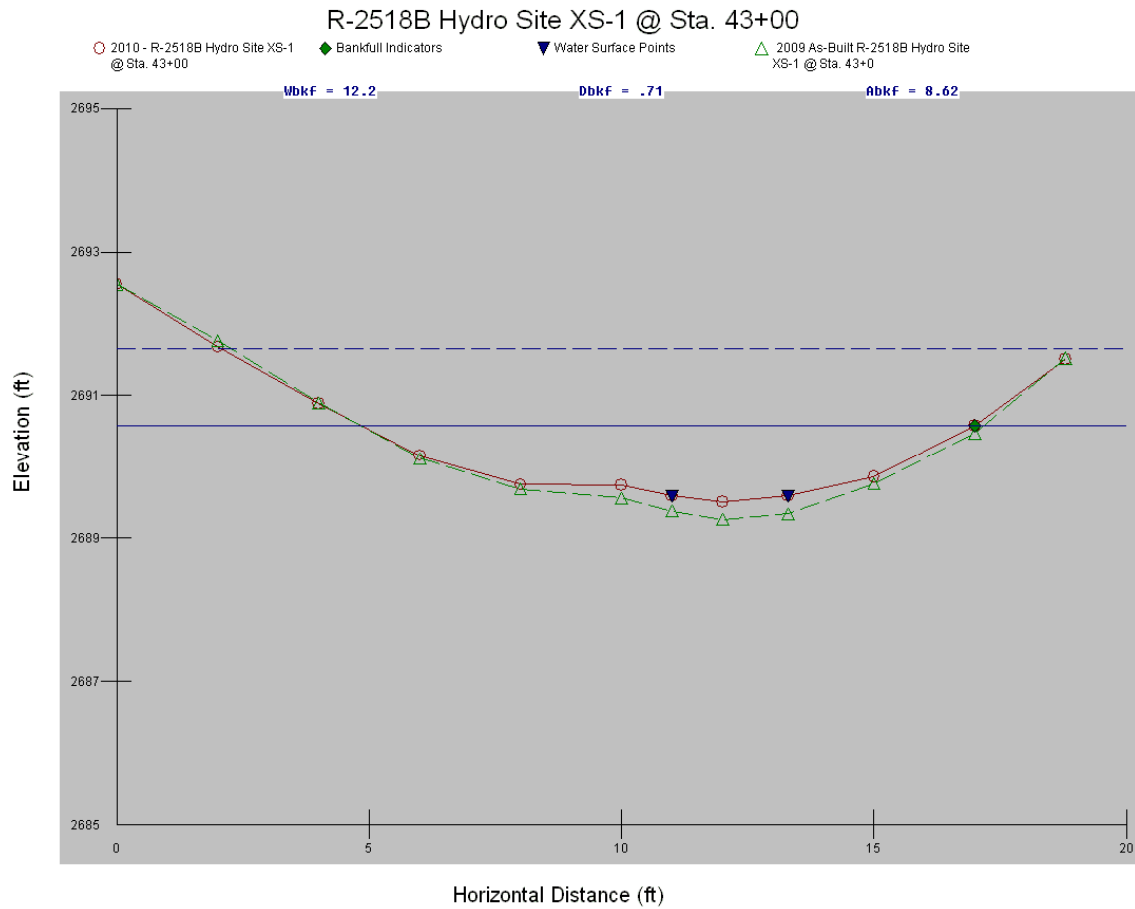
Hydro Site: Cross-Section #1 (Riffle) Abbreviated Morphological Summary					
	2010	2011	2012	2013	2014
Bankfull Cross Sectional Area (ft ²)	8.62				
Maximum Bankfull Depth (ft)	1.07				
Width of the Floodprone Area (ft)	16.72				
Bankfull Mean Depth (ft)	0.71				
Width/Depth Ratio	17.11				
Entrenchment Ratio	1.38				
Bankfull Width (ft)	12.15

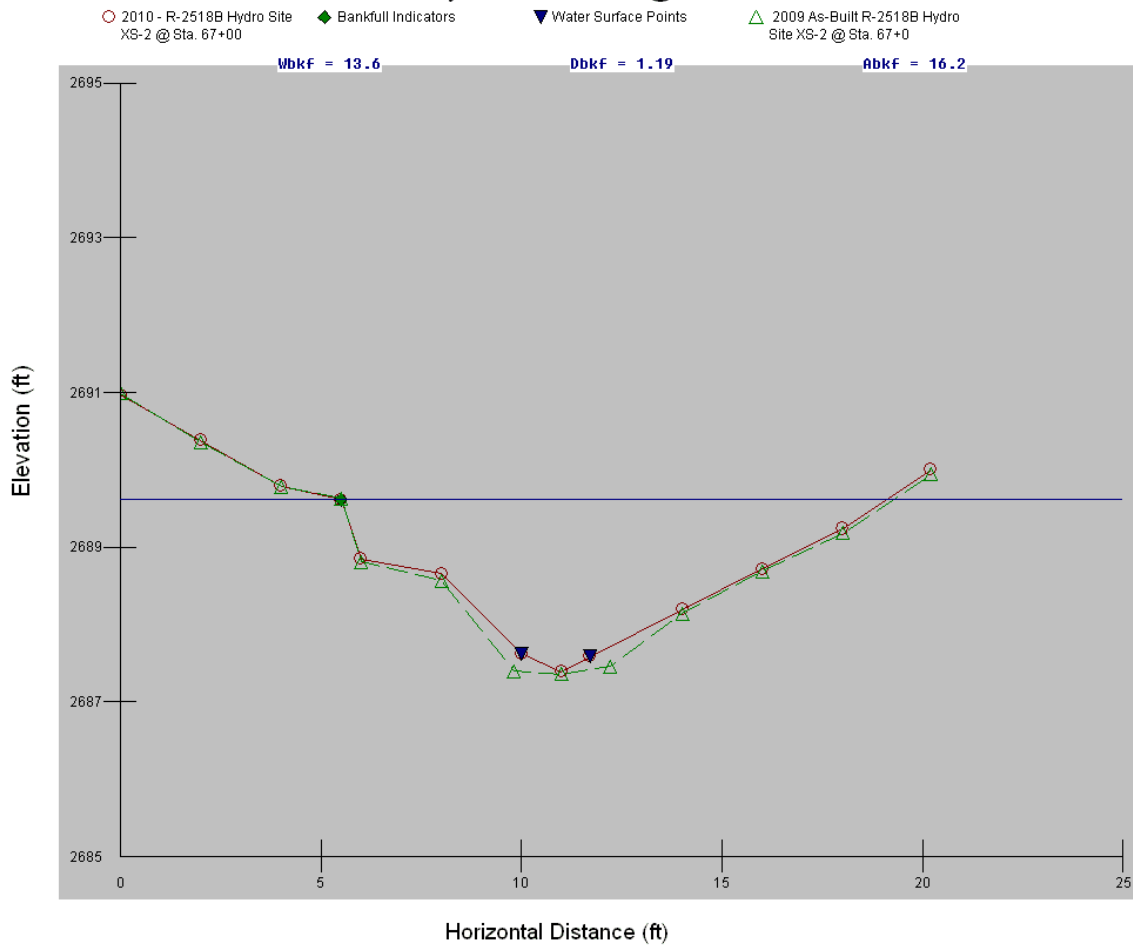
R-2518B Hydro Site XS-2 @ Sta. 67+00

Hydro Site: Cross-Section #2 (Pool) Abbreviated Morphological Summary*

2010	2011	2012	2013	2014
Bankfull Cross Sectional Area (ft ²)	16.25				
Maximum Bankfull Depth (ft)	2.23				
Bankfull Mean Depth (ft)	1.19				
Bankfull Width (ft)	13.6

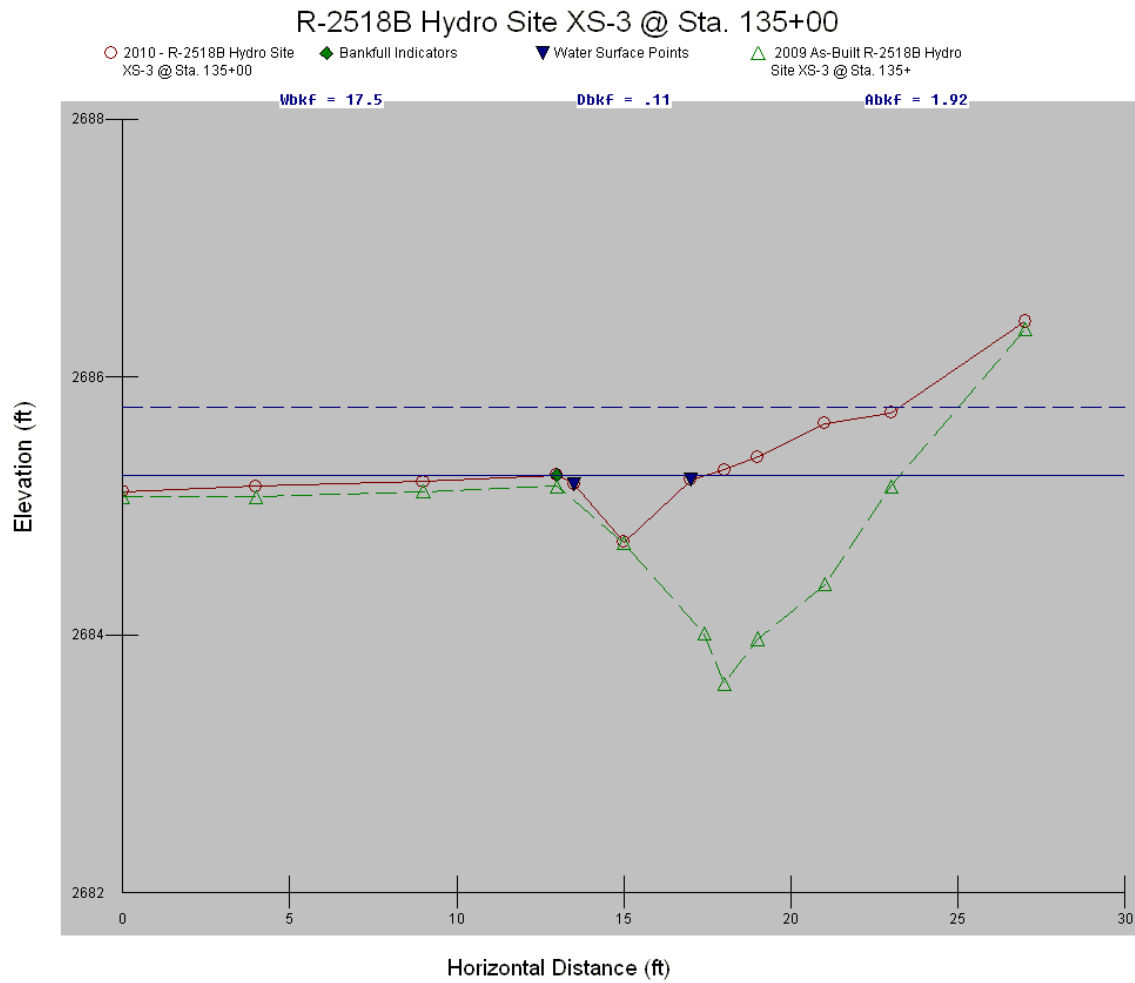
Hydro Site: Cross-Section #3 (Riffle) Abbreviated Morphological Summary					
	2010	2011	2012	2013	2014
Bankfull Cross Sectional Area (ft ²)	1.03				
Maximum Bankfull Depth (ft)	0.52				
Width of the Floodprone Area (ft)	23.23				
Bankfull Mean Depth (ft)	0.23				
Width/Depth Ratio	19.57				
Entrenchment Ratio	5.16				
Bankfull Width (ft)	4.5

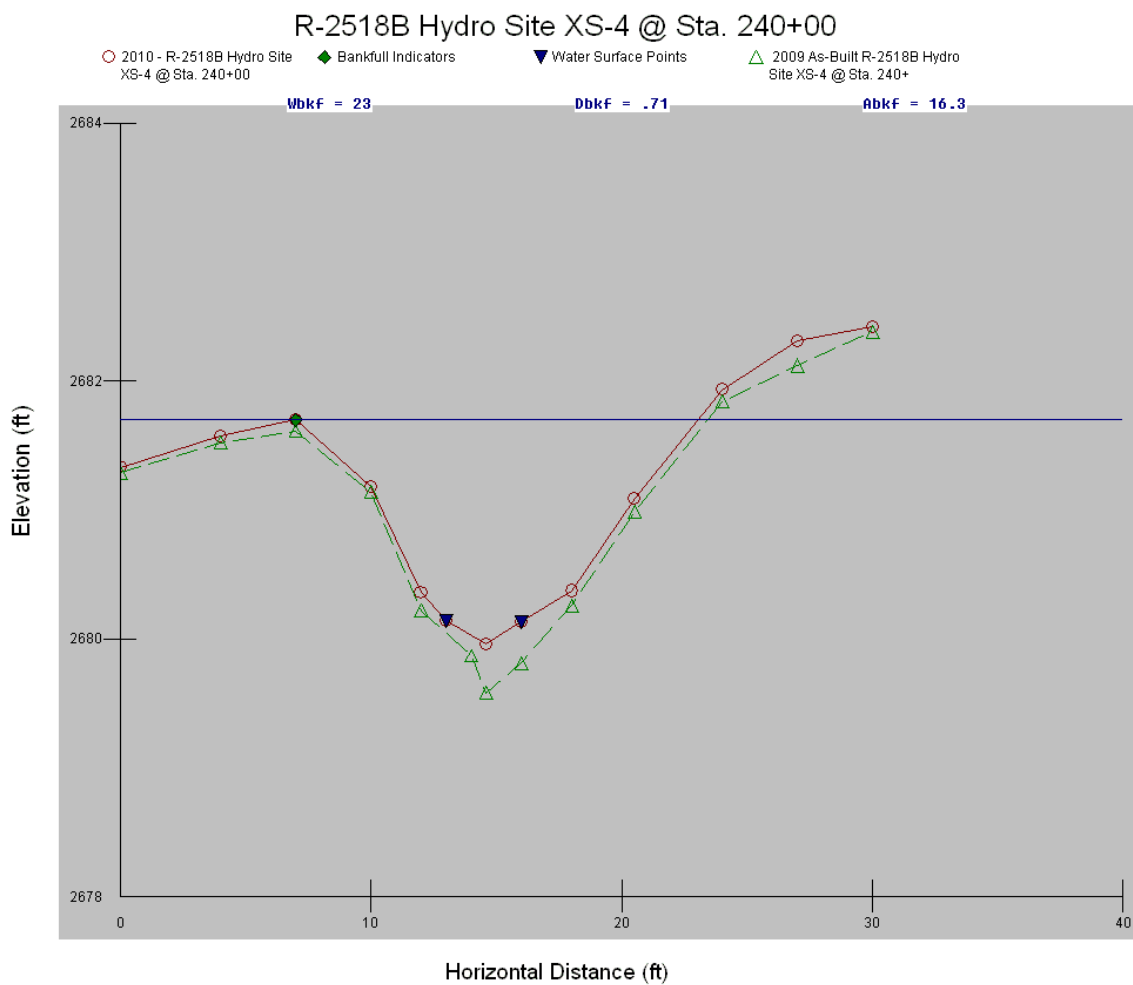
Hydro Site: Cross-Section #4 (Pool) Abbreviated Morphological Summary*					
	2010	2011	2012	2013	2014
Bankfull Cross Sectional Area (ft ²)	15.15				
Maximum Bankfull Depth (ft)	1.74				
Bankfull Mean Depth (ft)	0.94				
Bankfull Width (ft)	16.04

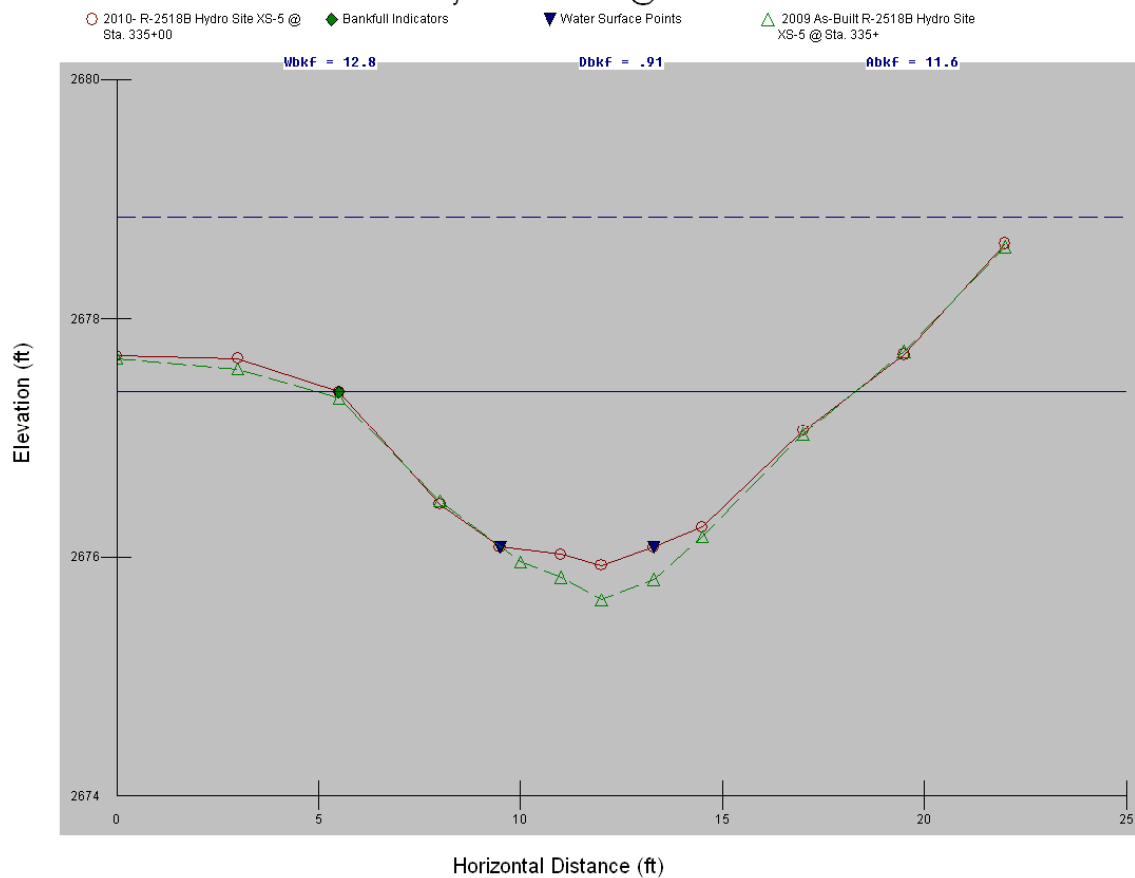
R-2518B Hydro Site XS-5 @ Sta. 335+00

Hydro Site: Cross-Section #5 (Riffle) Abbreviated Morphological Summary					
	2010	2011	2012	2013	2014
Bankfull Cross Sectional Area (ft ²)	11.63				
Maximum Bankfull Depth (ft)	1.46				
Width of the Floodprone Area (ft)	22				
Bankfull Mean Depth (ft)	0.91				
Width/Depth Ratio	14.05				
Entrenchment Ratio	1.72				
Bankfull Width (ft)	12.79
